SCREENING SITE INSPECTION WORK PLAN
OF
CABOT LANDFILL
(ARD983269275)

Prepared By
Michael Watson, FIT Chemist
Ecology and Environment, Inc.
Region VI
February 14, 1991

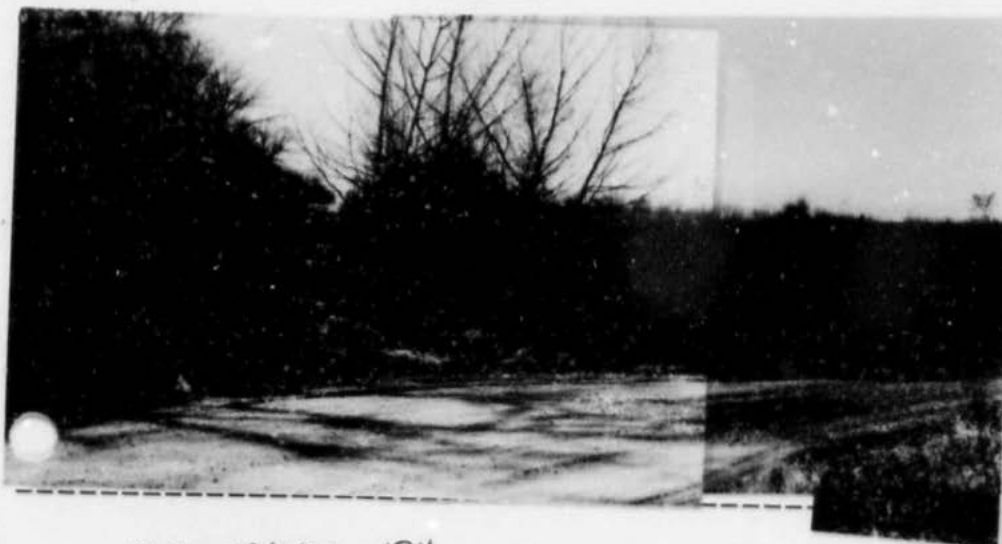
14

Site Name Cabot Landfill
Location Cabot / Lonoke / Arkansas
CERCLIS # ARD9E3269275
Photographer/Witness Michael Watson / Julie Keke
Date 1/25/91 Time 11:00 Direction _____
Description 180 degree scan (NW to NE) of bath
cells (1 of 4)

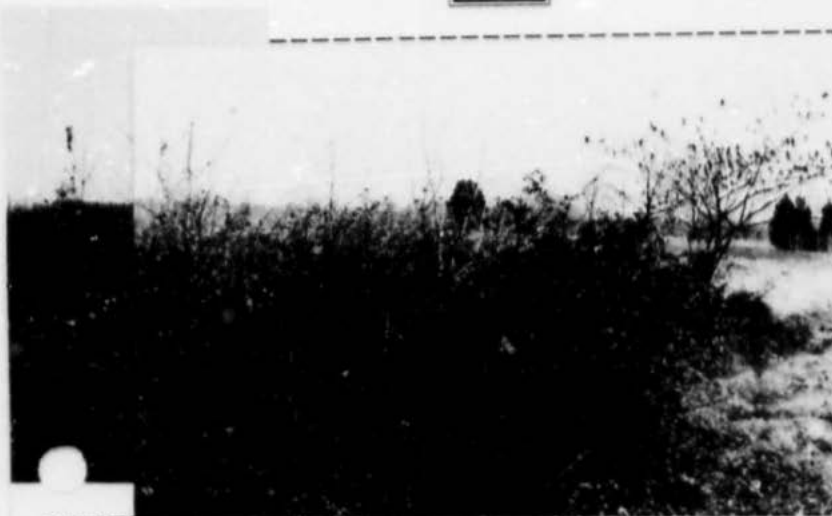
10

Site Name Cabat Landfill
Location Cabat / Lencke / Arkansas
CERCLIS # ARD983269275
Photographer/Witness Michael Watson / Julie Koke
Date 1/25/91 Time 11:00 Direction _____
Description 180 degree scan (NW to NE) of both
cells (4 of 4).

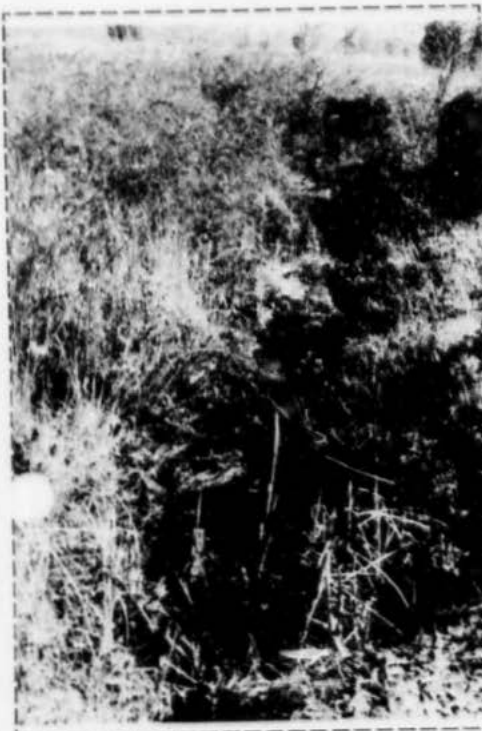
2

Description Drainage ditch
contents originated at
spring (intermittent)

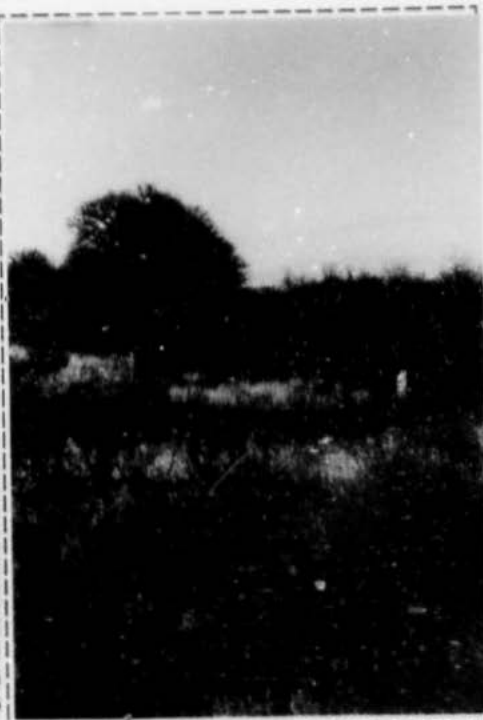
3

Description Abandoned Tires

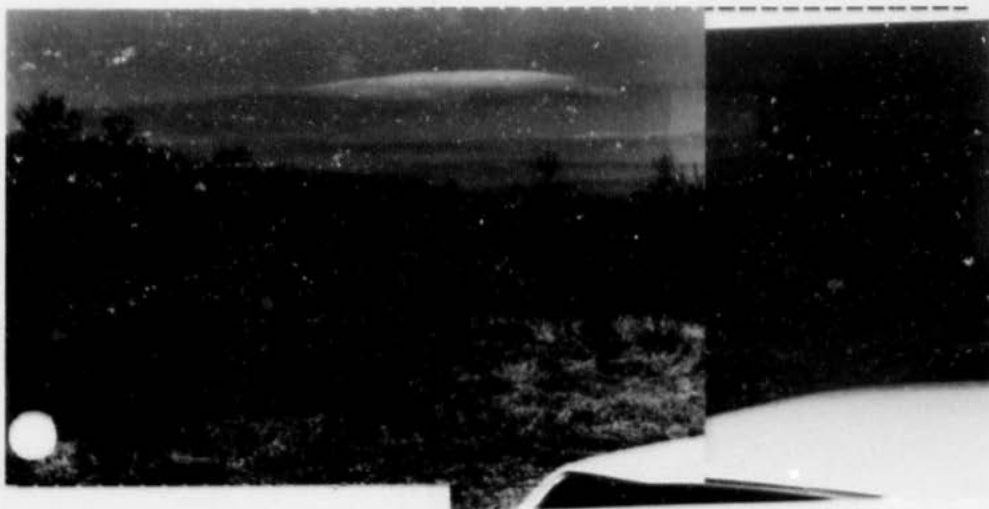
4A

Description Most recent cell (capped in 1985)

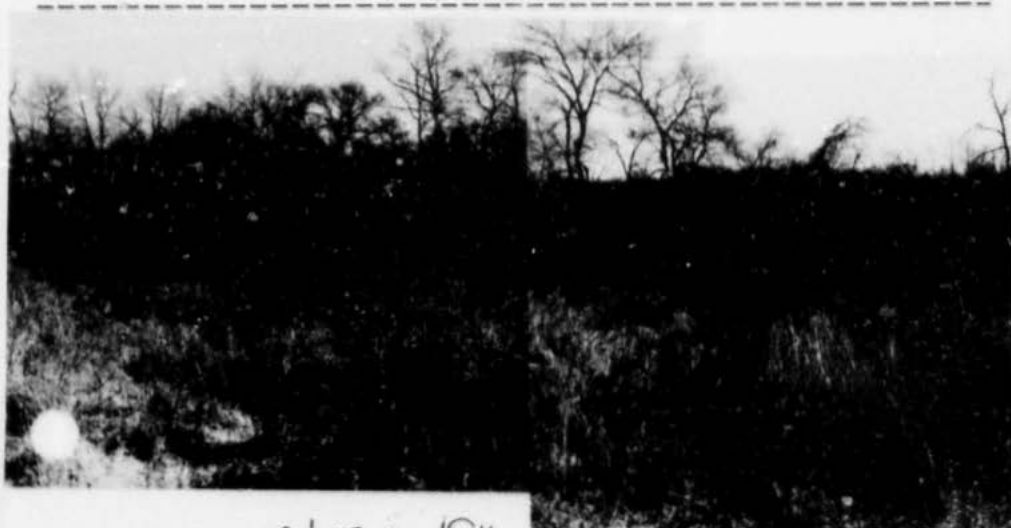
5A

Site Name Cabot Landfill
Location Cabot / Hencke / Arkansas
CERCLIS # ARD983069275
Photographer/Witness Michael Watson / Julie Keke
Date 1/25/91 Time 12:25 Direction N To E
Description General Area of Spring & Willow Trees
(let 3)

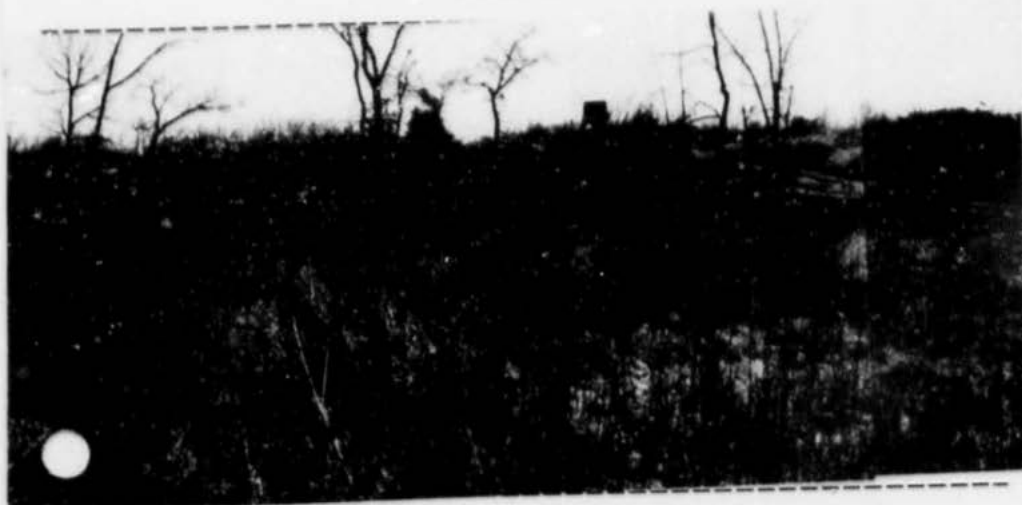
58

Site Name Cabot Landfill
Location Cabot / Leake / Arkansas
CERCLIS # ARD983269275
Photographer/Witness Michael Watson / Julie Koke
Date 1/25/91 Time 12.25 Direction West To East
Description GENERAL AREA of Spring & Willow TREES
(2 of 3)

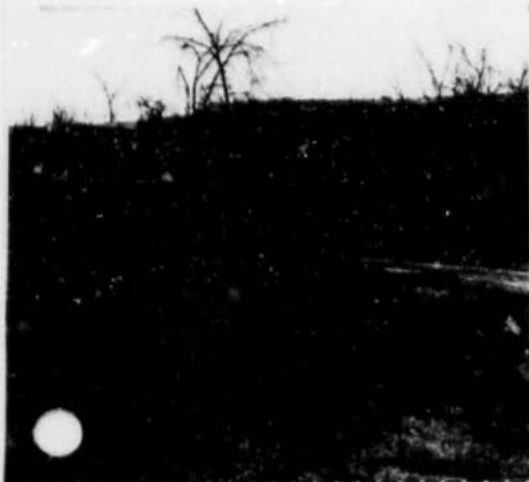
5C

Site Name Cabat Landfill
Location Cabat/Loucke/Arkansas
CERCLIS # ARD983269275
Photographer/Witness Michael Watson / Julie Kake
Date 1/25/91 Time 12:25 Direction West To East
Description GENERAL AREA of Spring & Willow
TREES (3 of 3).

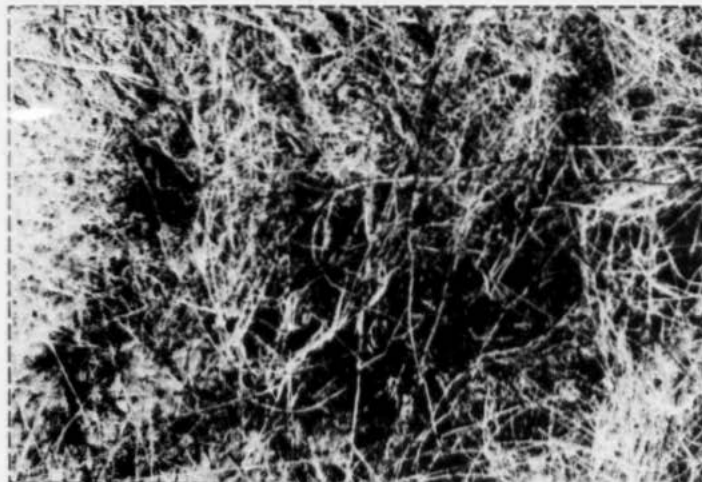
7

Description Spring Closeup

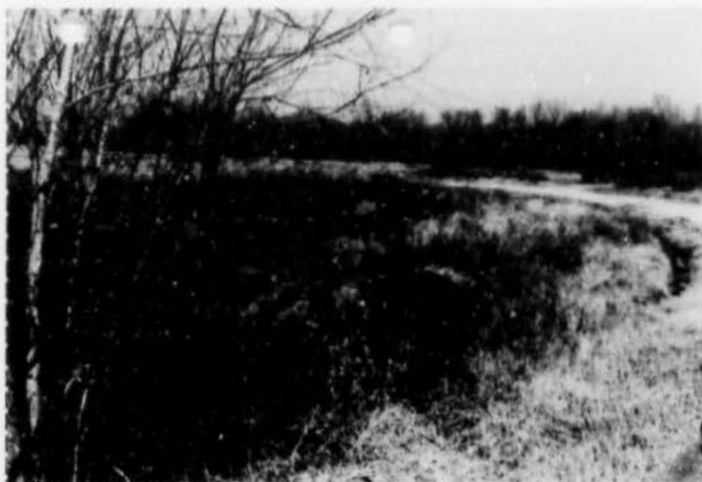
9

Description Drawings pathway of spring

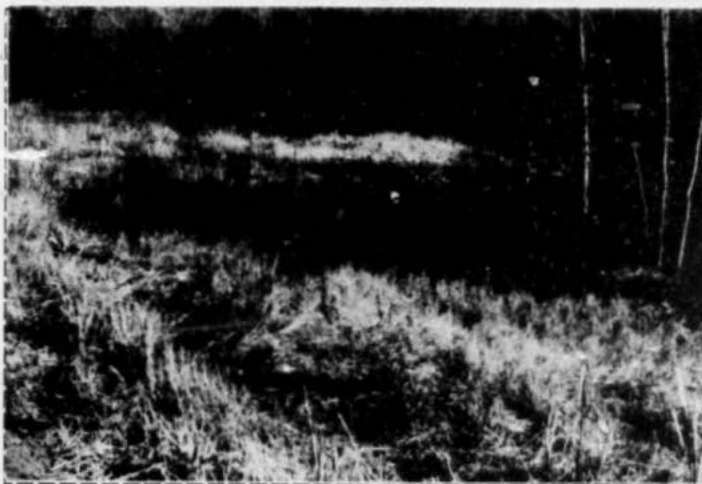
Description Road resulting from spring

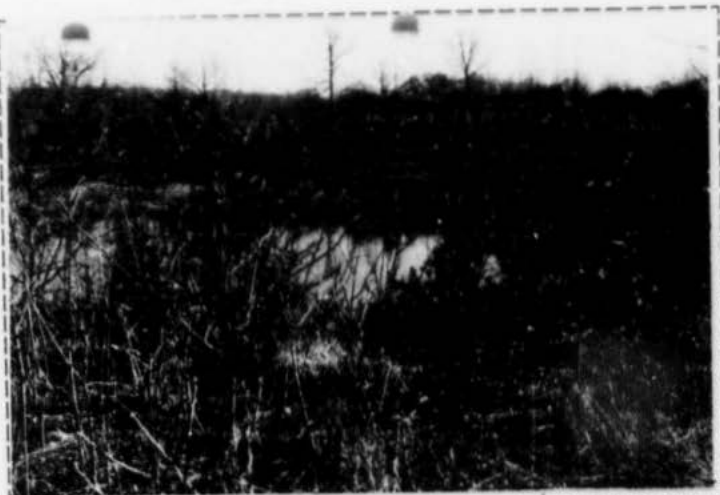
10

Description Stock Pond on site
(not a result of the landfill
used by deer)
